Casualty Information

Information from DNV to the maritime industry No. 4-10 May 2010

Rudder trunk used for smuggling

Ship type: General cargo Size (GT): any Year built: any

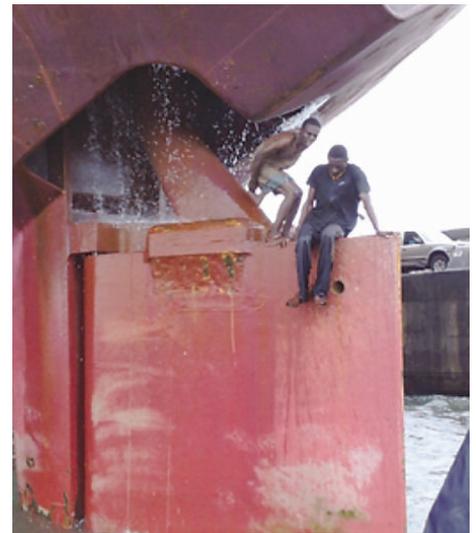
On more than one occasion, vessels have been arrested in port, after discovering cocaine (as much as 100–300 kg) and stowaways in the rudder trunk of these vessels. The void space has been accessed from sea level, by climbing up into the trunk from underneath.

Fig.5: Picture from a port in Africa showing stowaways discovered in the rudder trunk (photo courtesy Zululand Observer).
